**MERRIMACK RIVER BASIN
MANCHESTER, NEW HAMPSHIRE**

HIGH SERVICE DISTRIBUTION RESERVOIR

**PHASE I INSPECTION REPORT
NATIONAL DAM INSPECTION PROGRAM**

APRIL 1979

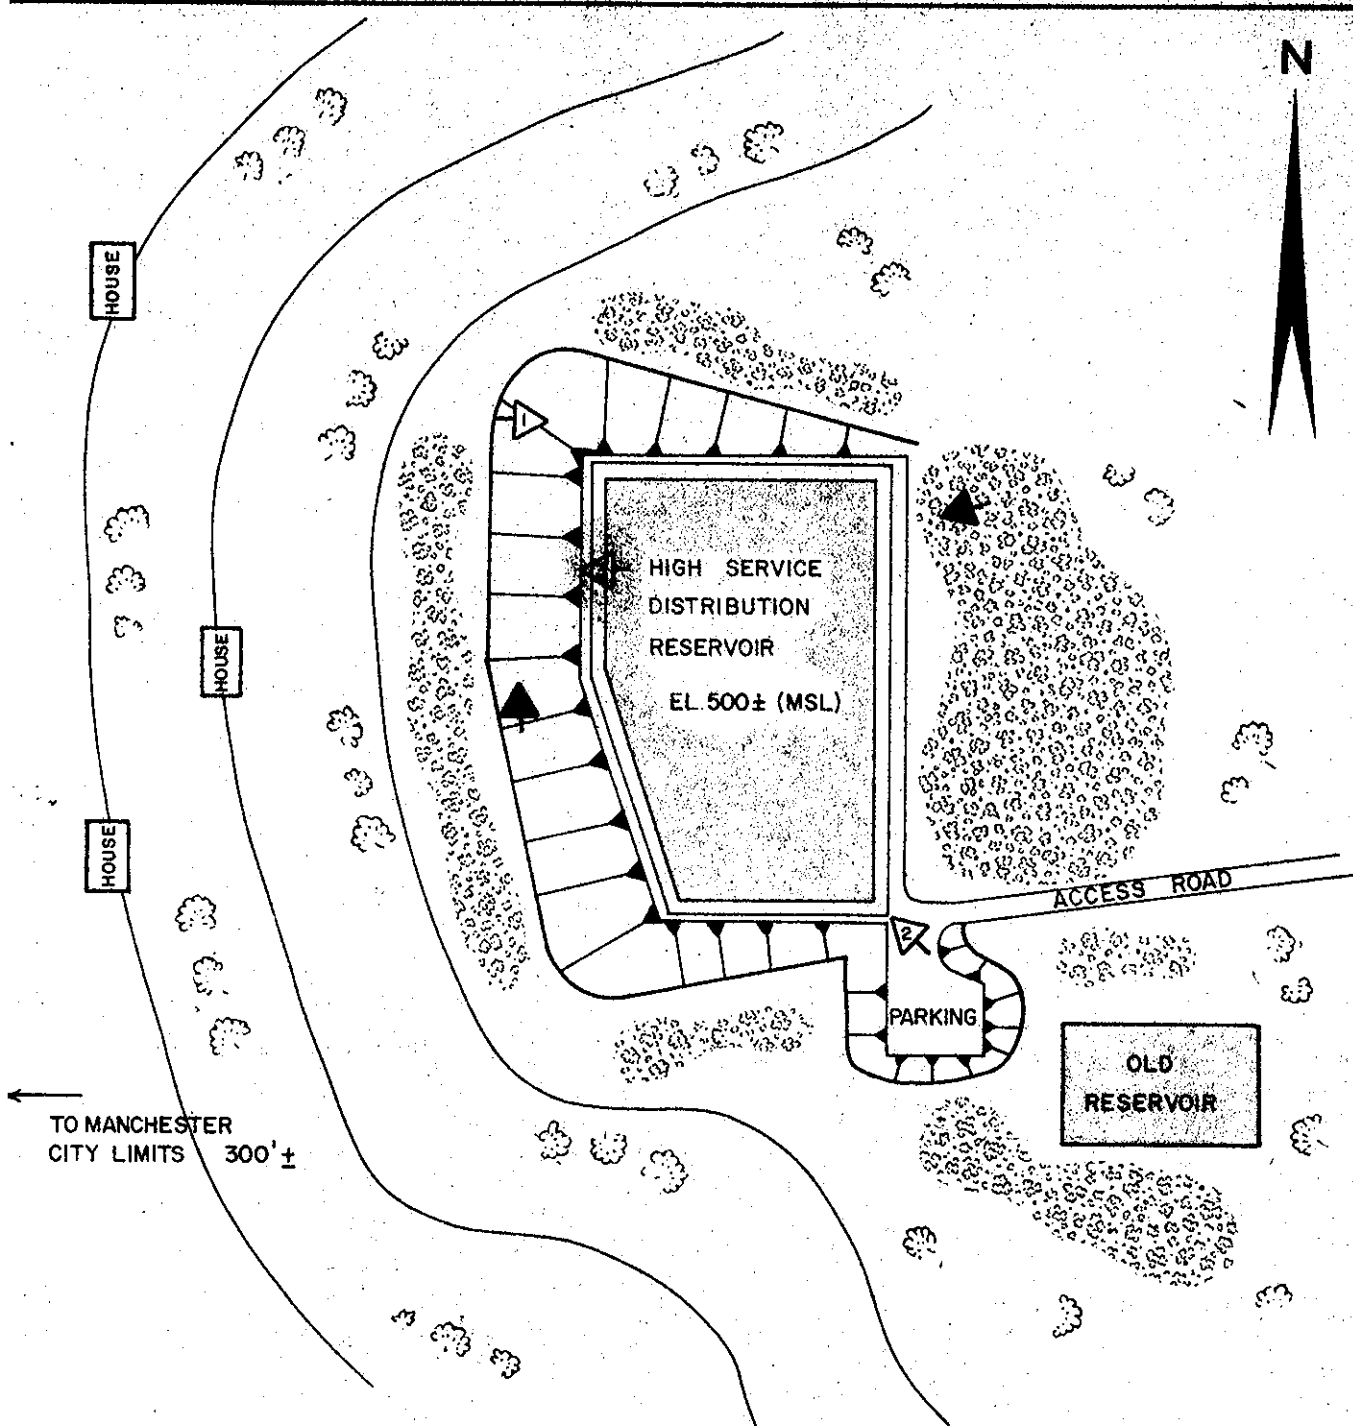
- OVERVIEW
- ▷ APPENDIX C

FILE No. 2201	GOLDBERG, ZOINO, DUNNICLIFF & ASSOC., INC. GEOTECHNICAL CONSULTANTS NEWTON UPPER FALLS, MASS.		U.S. ARMY ENGINEER DIV. NEW ENGLAND CORPS OF ENGINEERS WALTHAM, MASS.	
	NATIONAL PROGRAM OF INSPECTION OF NON-FED. DAMS			
	LOCATION AND ORIENTATION OF PHOTOS			
	H.S. DISTRIBUTION RESERVOIR		NEW HAMPSHIRE	
		SCALE 1" ≈ 200'		
		DATE NOVEMBER 1978
